# Manhole Inspection Summary

Manhole # S33K\_\_020MH

Insp Date: **12/15/08 11:58 AM**

**Location** Address: **555 s hanover st**

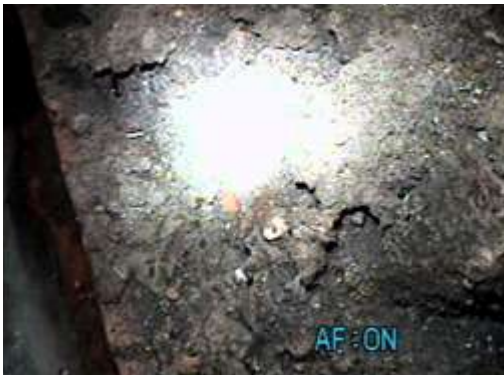
Defect 2

Condition: ☐ Sound ☐ Cracked ☐ Root Intrusion ☐ Deteriorated ☐ Leaks ☒ Debris

bench debris

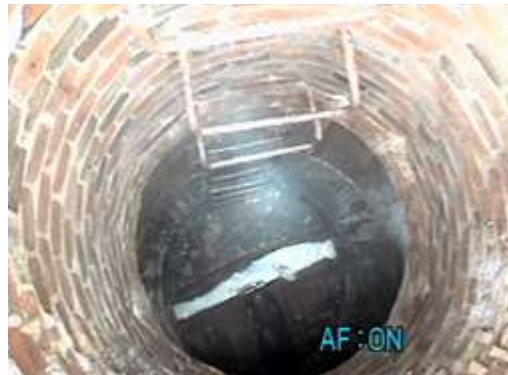
Defect 1

Count: **9** Missing: **0** ☒ Corroded

steps corroded

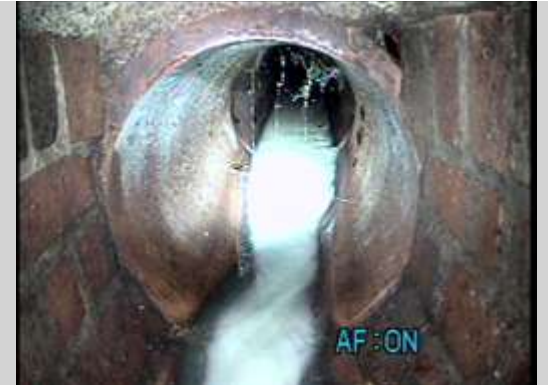
12 O'Clock Outflow

8 in. Circular Gravity Sewer  
Pipe Out @ 12 O'Clock

Deposits: ☒ None ☐ Mud ☐ Sludge ☐ Debris ☐ Grease

Infiltration: **None** Pipe Seal Cond: **Unknown**

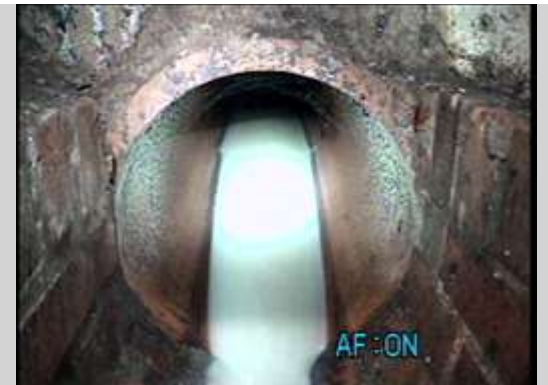
6 O'Clock Inflow

8 in. Circular Gravity Sewer  
Pipe In @ 6 O'Clock

Deposits: ☒ None ☐ Mud ☐ Sludge ☐ Debris ☐ Grease

Infiltration: **None** Pipe Seal Cond: **Unknown**

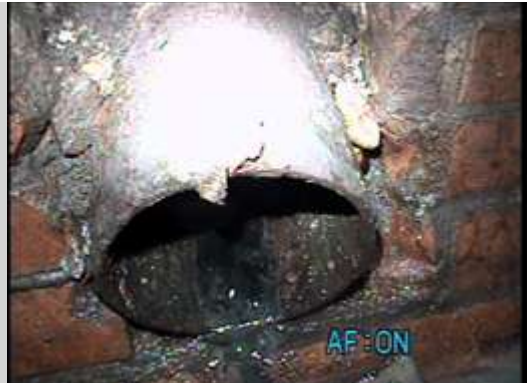
9 O'Clock Inflow

at the end of the channel not enough room to see inside

Deposits: ☒ None ☐ Mud ☐ Sludge ☐ Debris ☐ Grease

Infiltration: **None** Pipe Seal Cond: **Unknown**
